人と防災未来センター 巡回展パネル（B1×11枚）展示方法

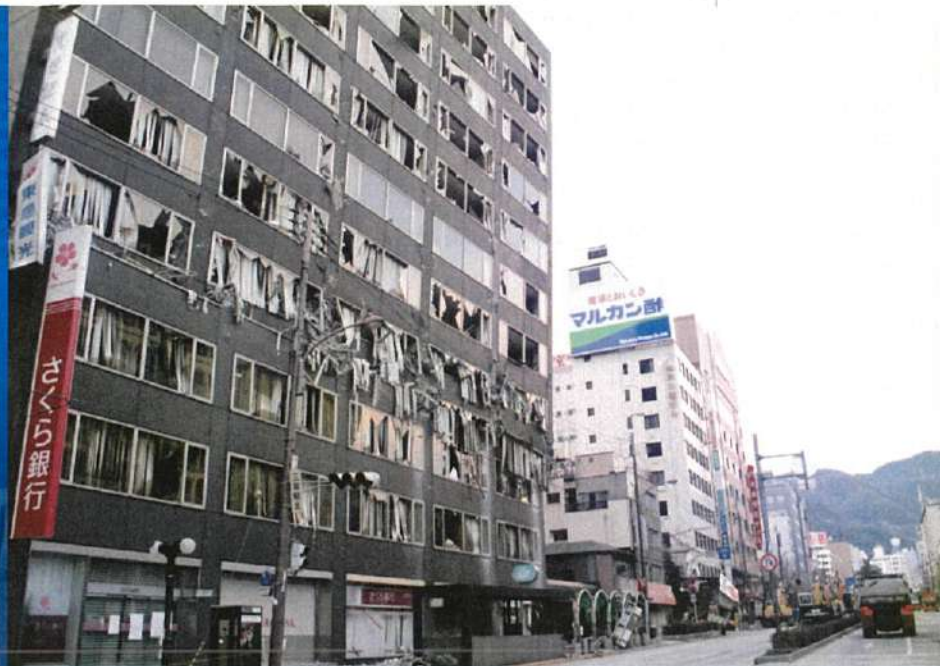
神戸の中心部、三宮の破損したビル。よく見ると4階部分がつぶれ、3階の上に5階部分が乗った状態に 神戸市中央区 1995.1.21
 Damaged building in Sannomiya, central Kobe. The fourth floor has completely collapsed and the fifth floor now sits on top of the third floor. Chuo Ward, Kobe City. 21 January 1995.

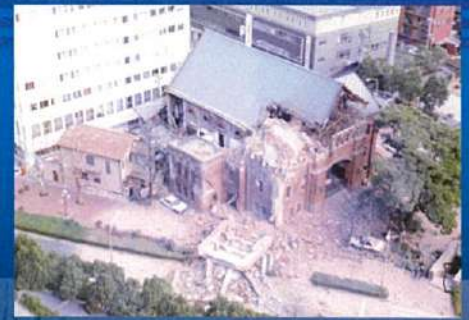
倒壊したゴシック様式の教会堂 神戸市中央区 1995.1.17
 Collapsed gothic style cathedral. Chuo Ward, Kobe City. 17 January 1995.

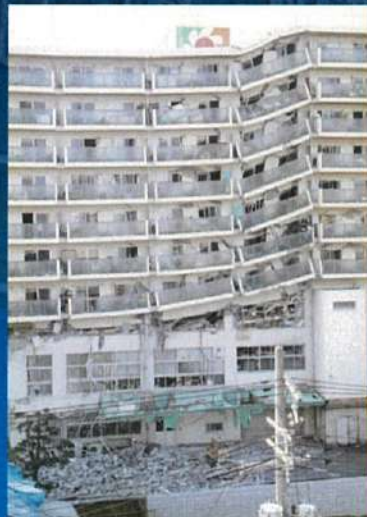
高層住宅の被災。低層の特定の階だけがつぶれ歪みが生じている 西宮市 1995.2.26
 Damaged high rise apartment block. Lower level floors have collapsed, distorting the building structure. Minatogami City. 26 February 1995.

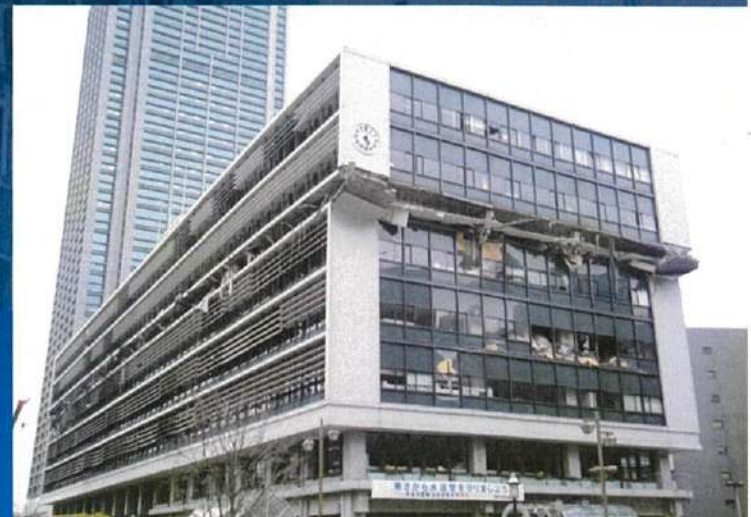
8階建ての6階部分がつぶれた神戸市庁舎2号館。その後、6階より上層を除去し5階建ての建物として再建された 神戸市中央区 1995.1.23
 Kobe City No. 2 government office building. The sixth floor of the eight storey building has collapsed. It has been reconstructed as a five storey building, with the upper floors removed. Chuo Ward, Kobe City. 23 January 1995.

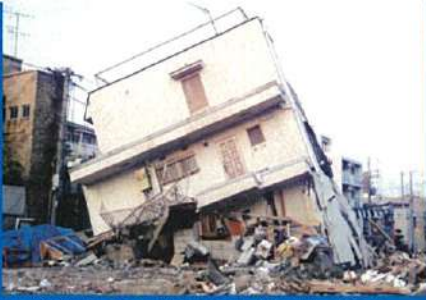
1 階片側の柱が折れ、大きく傾いた3階建ての住宅 神戸市東灘区 1995.2.26
A broken support pillar on one side of the ground floor caused this three storey house to tilt severely. Higashi Nada Ward, Kobe City. 26 February 1995.

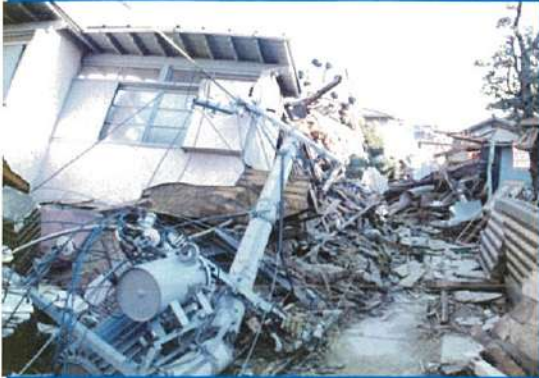
家屋の倒壊とふさがれた道路 神戸市東灘区 1995.1.24
Collapsed house is blocking the road. Higashi Nada Ward, Kobe City. 24 January 1995.

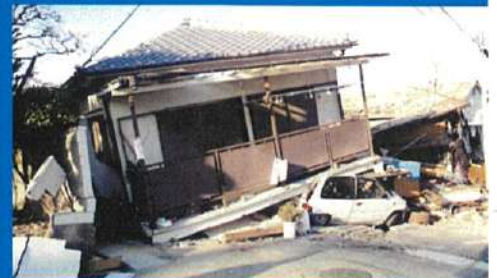
木造家屋の1階部分が崩壊し、2階部分が車を押しつぶしている 丹波市 1995.2.21
The ground floor of a wooden house has collapsed and the upper floor has crashed the car below. Aishiya City. 21 February 1995.

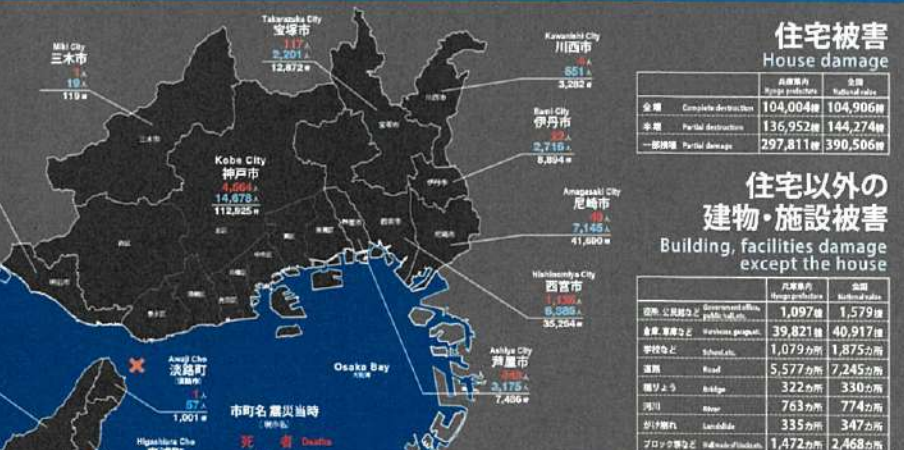
兵庫県 Hyogo prefecture	全国 National total
死者 Deaths	6,402人	6,434人
行方不明者 Missing person	3人	3人
重傷者 Seriously wounded person	10,494人	10,683人
軽傷者 The light injured	29,598人	33,109人

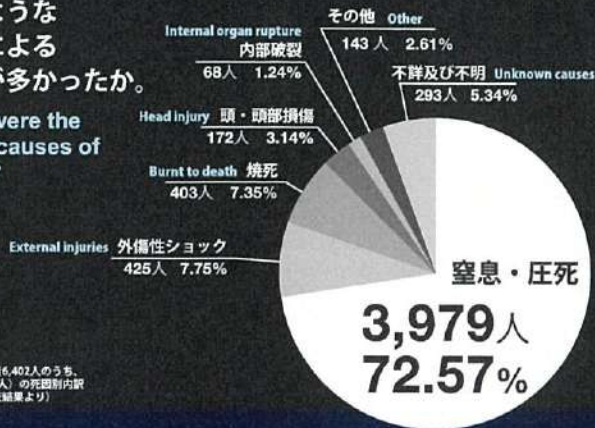
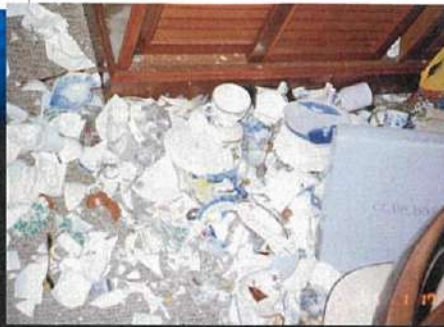
民家の中、食器類が粉々に割れ、散乱。1995.1.17
Inside a house. Dishes are all in pieces and scattered everywhere. 1995.1.17

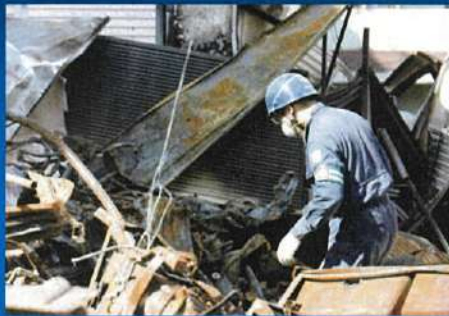
兵庫県警の機動隊員による焼け跡での捜索活動 神戸市兵庫区 1995.1.27
Hyogo Prefecture Fire special squad member searching through the damaged rubble. Hyogo Ward, Kobe City, 27 January 1995.

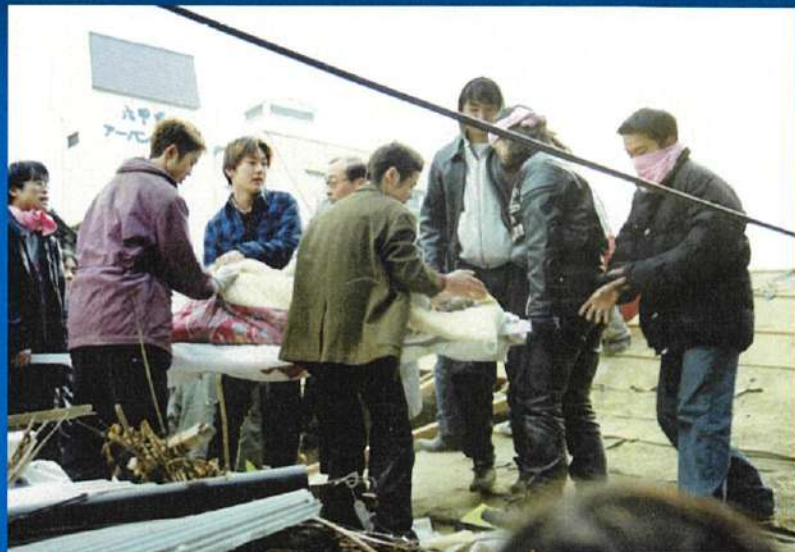
倒壊家屋の下敷きになった人の救出活動。多くの人が近隣の住居によって救出された。神戸市灘区 1995.1.17
Rescue operations for those who had been buried in collapsed houses. Many of the people pulled from the rubble were rescued by neighbors. Nada Ward, Kobe City, 17 January 1995.

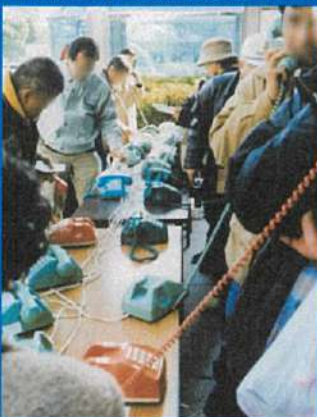
被災者の安否を伝えたり、たずねる張り紙。つぶれた住宅の壁や、倒れた住宅跡などに張り出された。Notice board in the burnt-out ruins, displaying information about survivors.

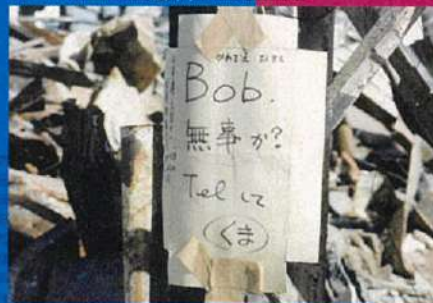
被災地域の人々の安否の確認も困難を極めました。Safety confirmation was difficult in the stricken area.

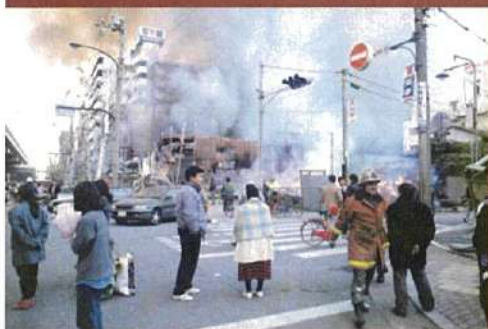
延焼が続く火災現場付近。神戸市長田区では木造密集層が密集するエリアを中心に火災による甚大な被害が出た 神戸市長田区 1995.1.17
Area damaged by fire. Heavy fire damage occurred in the area around Nagata Ward in Kobe City, which has a high concentration of wooden houses. Nagata Ward, Kobe City. 17 January 1995.

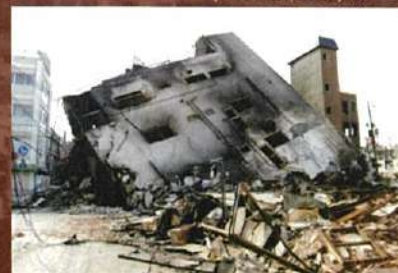
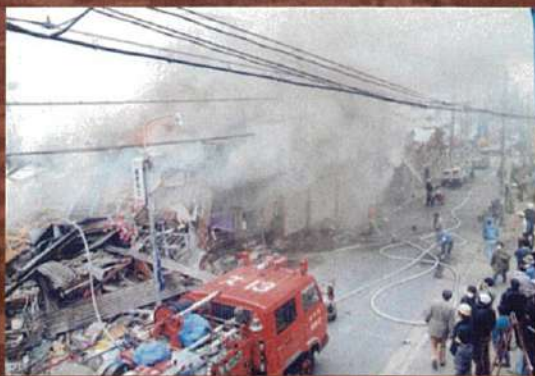
火災現場での消火活動。水道の断水、火災の同時多発、建物等の倒壊による道路通行の遮断等の理由が重なり、十分な消火活動ができない現場も多くあった。神戸市長田区 1995.1.17
Extinguishing fires. Broken water pipes, multiple fires and fallen buildings blocking roads prevented adequate firefighting in many cases. Nagata Ward, Kobe City. 17 January 1995.

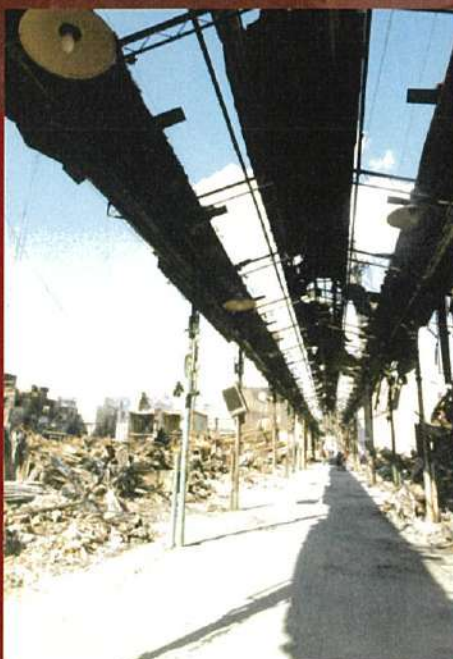
地震から約1か月後の焼け跡の様子。建物・道路の区別が難しいほど焼失 神戸市長田区 1995.2.21
Fire damage in Nagata Ward one month after the earthquake. Damage is so severe that it is difficult to distinguish between buildings and roads. Nagata Ward, Kobe City. 21 February 1995.

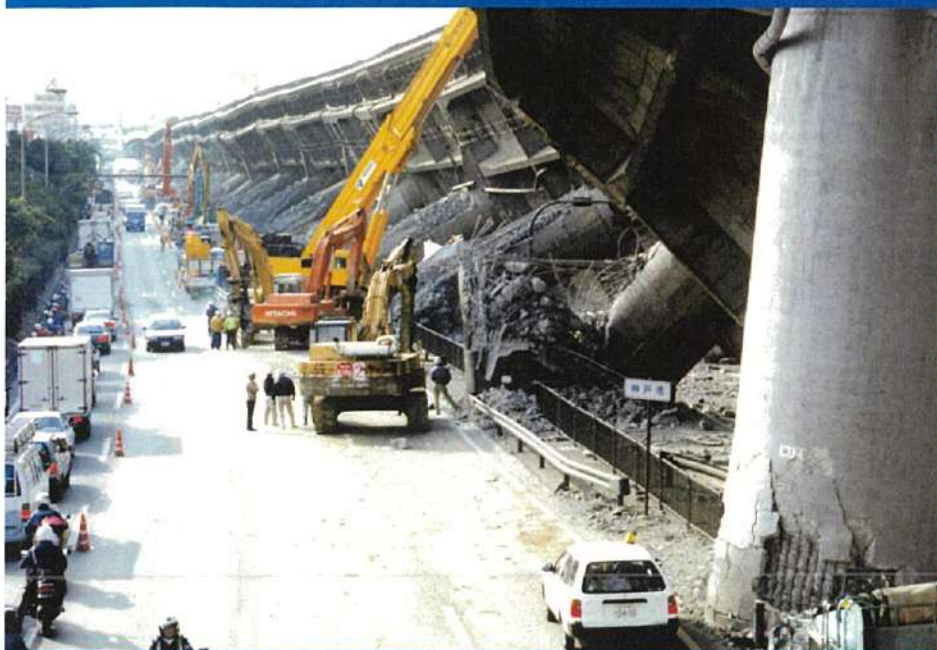
横倒しになった高速道路は震災の被害の甚大さを伝える象徴的なシーンとなった。震災発生から2日後、復旧工事が始まっている 神戸市東灘区 1995.1.19
This collapsed elevated highway became an iconic scene showing the enormity of damage caused by the earthquake. Reconstruction began 2 days after the quake, Higashi Taifa Ward, Kobe City. 19 January 1995.

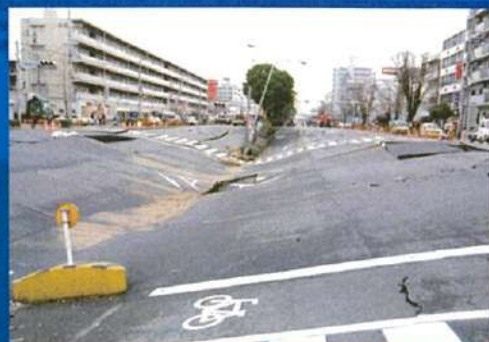
道路の陥没、国道28号線、地下に神戸高速鉄道 大開駅がある付近 神戸市長瀬区 1995.1.23
Caved in road, National Highway Route No. 28, near Daikai Station on the underground Kobe Rapid Transit Railway, Higashi Ward, Kobe City. 23 January 1995.

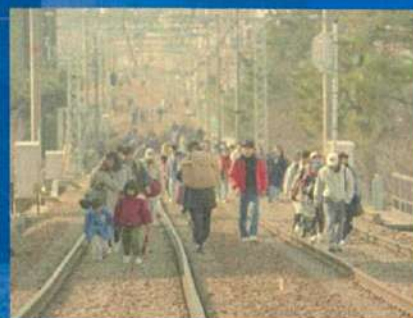
線路上をリュックを背負い歩く人々の姿が、被災地の様子を伝える一つの光景になった
People with backpacks walking on the train lines became one of the iconic images of the disaster affected area.

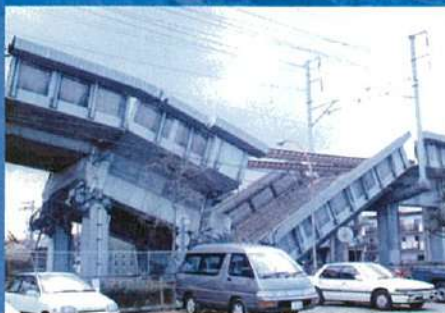
鉄道の高架線路の一部が外れて地上に落ちている 西宮市 1995.1.24
Part of an elevated railway has broken away and falls. Nishinomiya City. 24 January 1995.

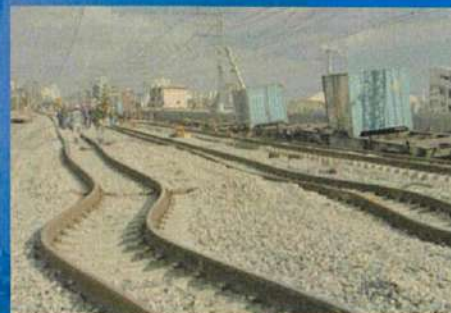
地震によって大きく湾曲してしまった線路
Railway lines have been bent and twisted by the force of the earthquake.

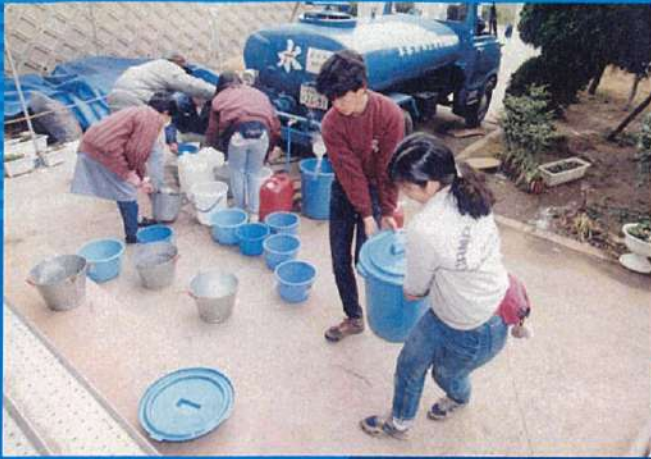
断水し、給水車で届けられた水を協力して運ぶ人々
People cooperating to carry the water delivered by water tankers, as the water pipes were broken.

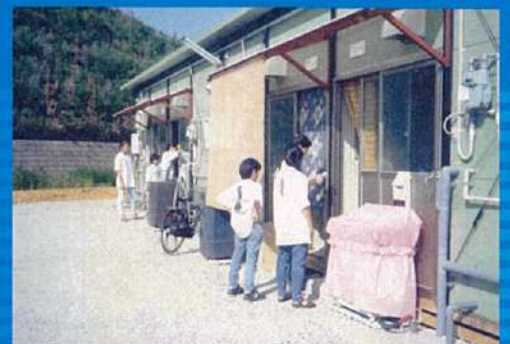
ピーク時には4万戸以上のあった仮設住宅、校舎等を段階的に取り壊し、心身の状態を確かめ、アルコール依存等を発症に防ぐなど、入居者への支援活動も行われた。
Temporary housing reached to peak at over 48,000 households. Support services for residents, such as visiting each household, checking on the physical and mental condition of residents, preventing alcoholism etc. was also carried out.

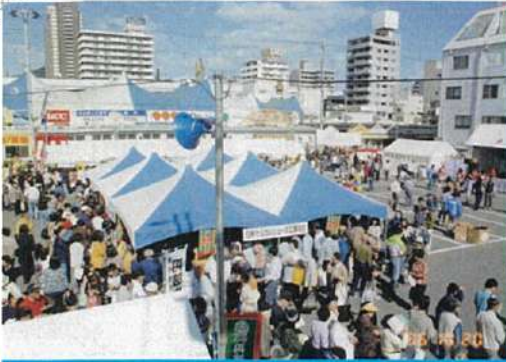
仮設店舗・仮設商店街。被災地の商店が本格再開するまでの一定期間、テント、プレハブなどを用いた仮設の店舗や商店街が生まれ、まちの復興に活力を与えた。
Temporary shops and shopping streets. Until shops could be reopened properly, tent and pre-fab shopping villages sprang up and contributed to the recovery of the city.
